Engine Polygraph® (enginepolygraph.com)

Diagnostic Report v6.50

GM 3.6L V6 VVT DI Physical Layout

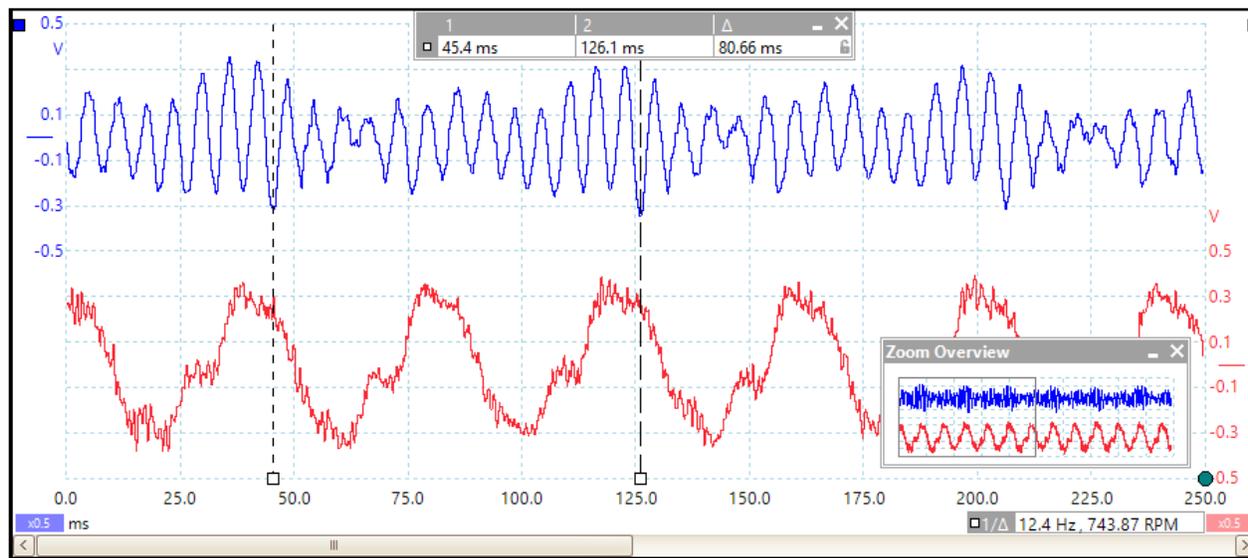
Figure 1: A SenX Signature using a PicoScope PC Oscilloscope

The above signature is from the exhaust (red) and a 'trigger file' from a spark plug induction clamp (blue) from a 6 year old, V6 engine. The vertical dashed bars mark the boundaries of a 720° full 2 rotations of the crankshaft which took 80.66 ms, indicating that the engine was running at idle of 1487.7 rpm. (You might notice that the oscilloscope indicates the rpm as 743.87 in the lower right corner. But we know that we have a 4-stroke engine requiring 2 rotations for all cylinders to fire once and this is a V6, so the rpm is twice the frequency of the 4-stroke frequency.) The cylinders are very regular.

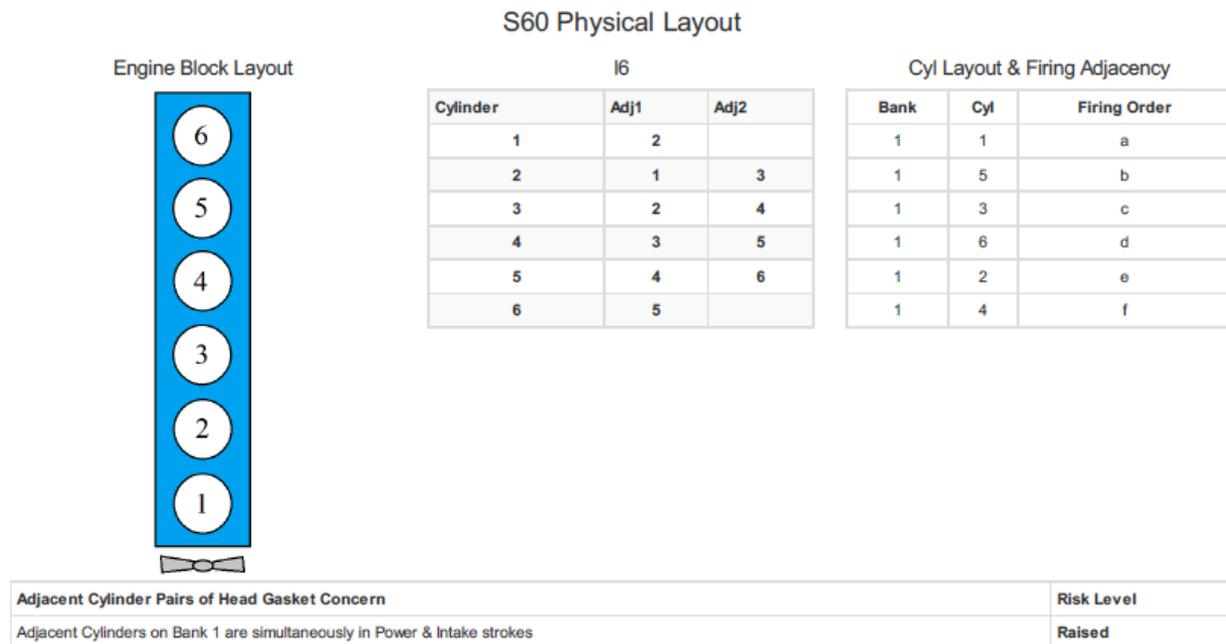
Figure 9: Example Engine Block Layout, Cylinder Adjacency, Bank Alignment and Firing Order.

The next page (Fig. 9) provides an illustration of the engine block with the cylinders numbered according to the manufacturer’s documentation (or as we have found it in the published literature). In addition, there are two tables:

1. An Adjacency Matrix that lists for each cylinder that cylinder’s adjacent cylinder numbers. This is to enable the program to determine which cylinders belong to which bank of the engine.
2. A Cylinder Layout and Firing Adjacency table that provides cylinder location in firing order sequence.

If there are pairs of cylinders that are neighbors that hit are simultaneously in a power and intake stroke, the bank of the engine that exhibits that situation is listed and a value for a “risk level” is indicated to alert the reader to the concern that a gasket rupture between those two cylinders is somewhat more likely that at that situation does not present itself. If an adjacent set of cylinders are simultaneously in a compression and intake stroke. A similar statement is issued with a less severe warning about risk.

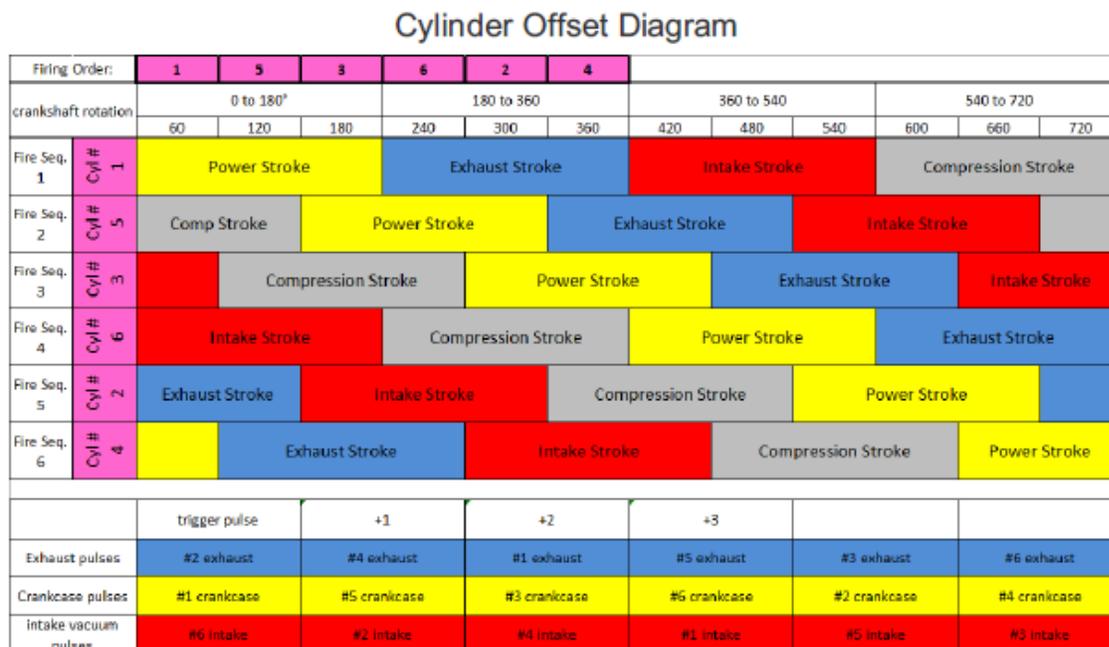
Fig. 10 illustrates the stroke of each cylinder throughout one engine cycle of one or two rotations, depending on how many strokes this engine uses. (The most typical situation is that one cycle requires 720° rotation of the crankshaft for each cylinder to fire once. The horizontal axis starts when cylinder one is at top dead center (TDC) after ignition has been started. The rows represent the cylinders in firing sequence order, but also showing the cylinder number as specified by the manufacturer. In the lower part of the diagram, the cylinder primarily responsible for creating pressure in the three compartments of the engine at any instant (crankshaft rotation) is listed.

This diagram can give insight as to the source of abnormal observations, when things are happening in a cylinder that are “abnormal” and so may be helpful in determining a cause.

Figure 10: Cylinder Offset table showing the relationship of cylinder identification by the manufacturer and the crankcase angular rotation to each cylinder's stroke. Below that, we show which cylinders are designed to contribute to pressure at three major locations (exhaust, crankcase, and intake manifold)..

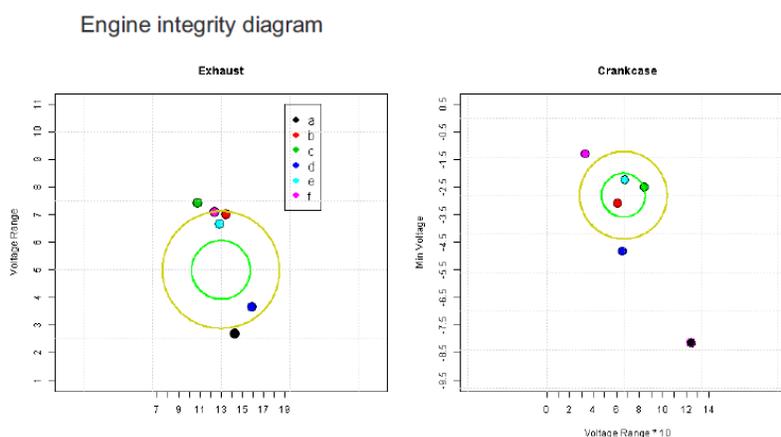
Figure 11: Engine Integrity diagram showing the (dis)similarity of the value of parameters for each cylinder derived from the Signature data.

The Engine Integrity Diagram shows values of key parameters for each cylinder. The cylinders are named alphabetically (a, b, c, etc.) in firing order sequence with unknown starting cylinder location. We call this the *Engine Integrity diagram* because if the points are close together, the engine has high integrity since all cylinders have similar operating parameters. (We are making the assumption that an engine would not have all cylinders in equally **bad** condition.) The green radius is would contain the points for most engines with score of 3 or better; the yellow circle would contain the points for most engines with scores 6 or better. The voltage is directly proportional to the pressure. (See Fig. 11.)

In the Exhaust graphic, the cylinder Duration is the number of milliseconds the exhaust from the cylinder takes to pass the exhaust sensor. (The Profile chart below might allow easier interpretation of the number of ms.) If the difference between the fastest and slowest cylinders exceeds 4 ms, the engine is running 'rough'. The vertical axis of the Exhaust chart shows the maximum voltage (pressure) observed by the sensor during the exhaust stroke for each cylinder. As you might expect, a cylinder with high exhaust output had a very successful power stroke and so the exhaust cycle should be fast due to the temperature of the power stroke. (So it will show in the upper left of the cluster.) Similarly, low voltage implies low cylinder output (cooler) and so a slower exhaust cycle; such a cylinder would present in the lower right of the cluster.)

Pairs of cylinders very close to each other indicate a very good engine. If a cylinder or two are higher and to the left of the circle center, that is no problem, but one very low or far to the right are signs of big trouble.

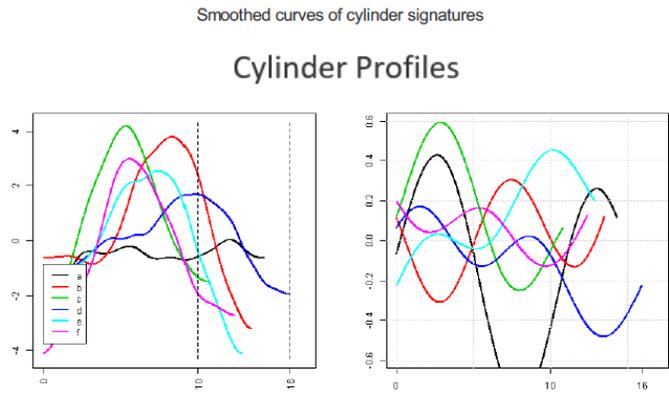
Figure 12: The Profiles graphics for the exhaust and crankcase for each cylinder.

The Exhaust Profiles show each cylinder's exhaust 'smoothed' voltages (pressure) for its section of the cycle. The cylinders are identified in firing order with colors; the legend shows the cylinder letter identifier with the assigned color. In a good engine, the profile lines are very similar. The starting point for each exhaust profile curve is mainly driven by the opening of the exhaust valve for the cylinder. Notice the 'severe' misfire (cylinder a of firing order in black) in the exhaust profile of Fig 12.

The Crankcase Profiles show the crankcase pressure from all cylinder actions during each cylinder's section of the cycle. These lines are usually arranged in pairs since the crankcase patterns repeat every 360° so each cylinder in the first 360° should have a match in the second 360°. Cylinders with differing blow-by will not be aligned together, or an intake manifold that has significant carbon buildup can cause the pairing to be ruined as the PCV valve can allow the vacuum variation to affect the crankcase pressure.

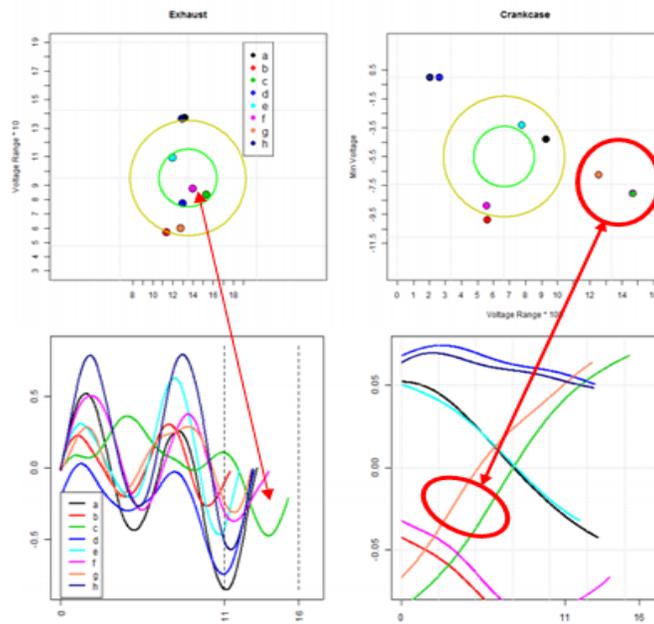
Figure 13: Illustration of using colors to relate data from differing graphics by cylinder.

Using a different engine's report, we illustrate the use of the colors for matching specific cylinders across the graphics. (See Fig. 13.)

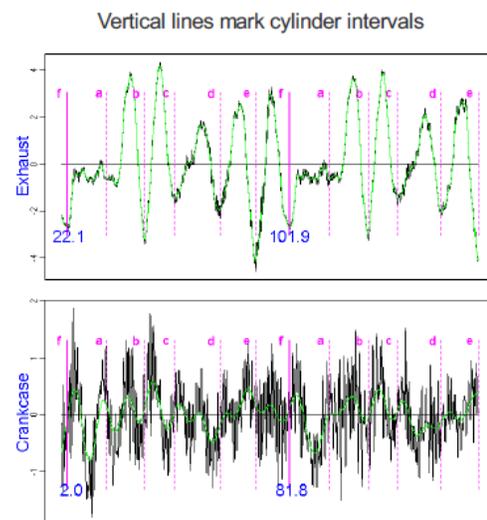
Figure 14: The Polygraph Model of the Pressure vs. vibration in the EP Signature for the subject engine.

The engine model on the right is a 6-cylinder engine running at about 1500 rpm (2 revolutions take about 80 ms at 1500 rpm for a 4-stroke engine. (Fig. 14)

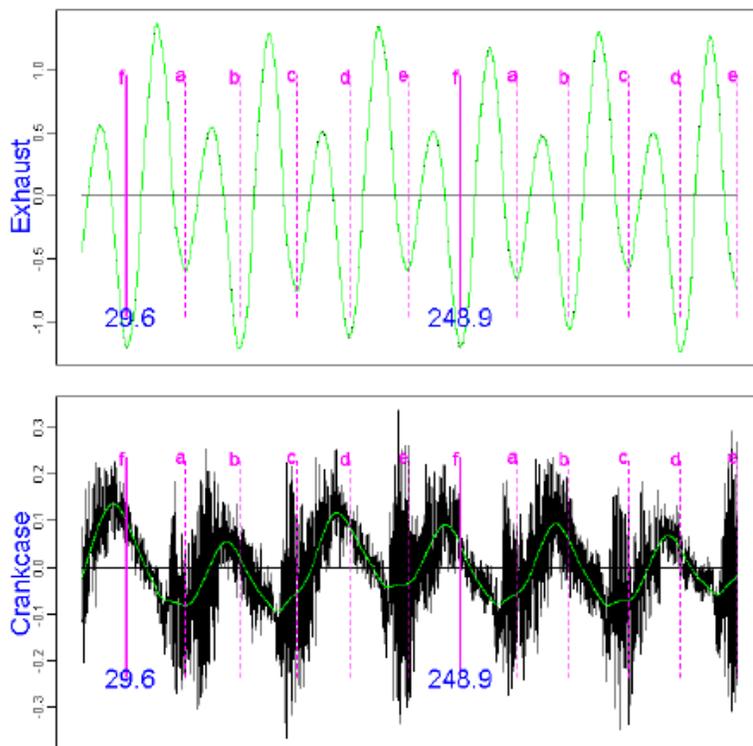
Fig. 15 Model graphic from a V6, 4-stroke cold-crank Engine Polygraph report

The Polygraph Model shown in figure 15 is from a 4-stroke, V6 engine in cold-crank. On the Exhaust Model, we see that the two banks of cylinders have very repeatable pressure and vacuum profiles. The difference between the two banks is a result of the design of the crossover allowing one bank to dominate over the other. For this reason, our analysis first looks at variation of cylinders in each bank before normalizing the results and comparing all cylinders together.

In the Crankcase Model, we see the cylinder pairing as the second rotation (cylinders d-e-f) repeat the pattern of a-b-c). But the details of the pairing will depend on the firing order of the cylinders. Also, when we look at the higher frequency activity, there is a noticeable difference between cylinders when the crankcase pressure is increasing vs. the much less intense when pressure is decreasing.
